# Prestan Professional Manikins

## Troubleshooting - CPR Rate Monitor Lights Not Working Properly

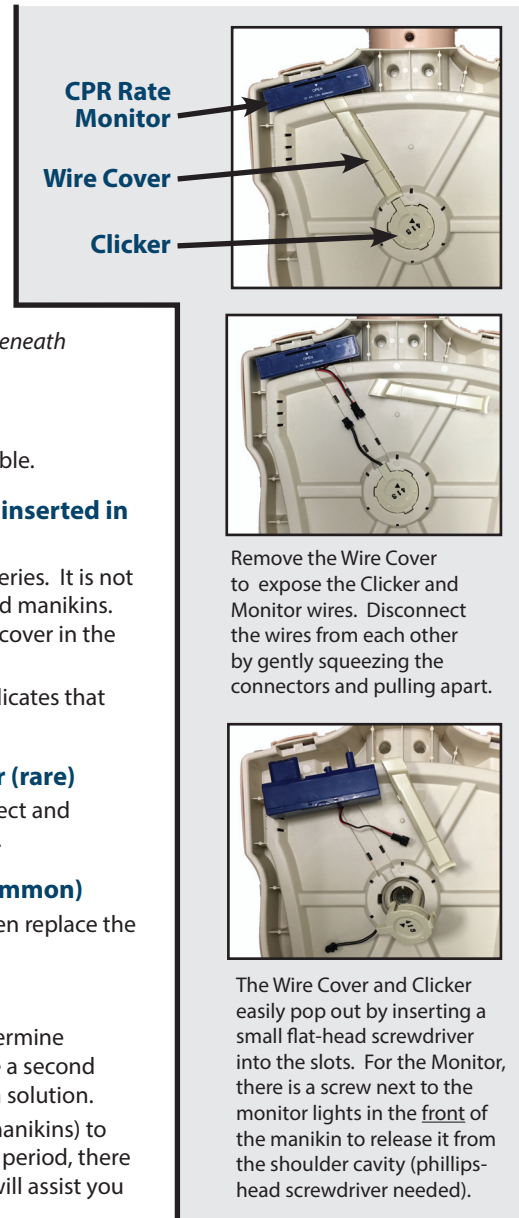
There are 2 working parts in a Prestan Professional Monitored Manikin: the mechanically-operated **Clicker** and the battery-operated **CPR Rate Monitor** (Monitor/Lights). The Monitor lights are powered by a small current, generated by the Clicker. The 2 parts connect to each other as shown in the photos (right).

- 3. Clicker and Monitor wires may have disconnected from each other (rare)**
  - > On the manikin's back, remove the Wire Cover (see photos right). Disconnect and reconnect the wiring to insure proper Clicker-to-Monitor communications.

- 4. Clicker may be clogged, interrupting the signal to the Monitor (common)**
  - > Remove the Clicker and lightly blow out any accumulated plastic dust. Then replace the Clicker and reconnect the Clicker wires to the Monitor wires.
